# **CRITICAL AREAS REPORT AND MITIGATION PLAN**

## **MILANO ISSAQUAH APARTMENTS**

### **ISSAQUAH, WASHINGTON**

18 September 2020  
(*Revised 15 September 2022*)

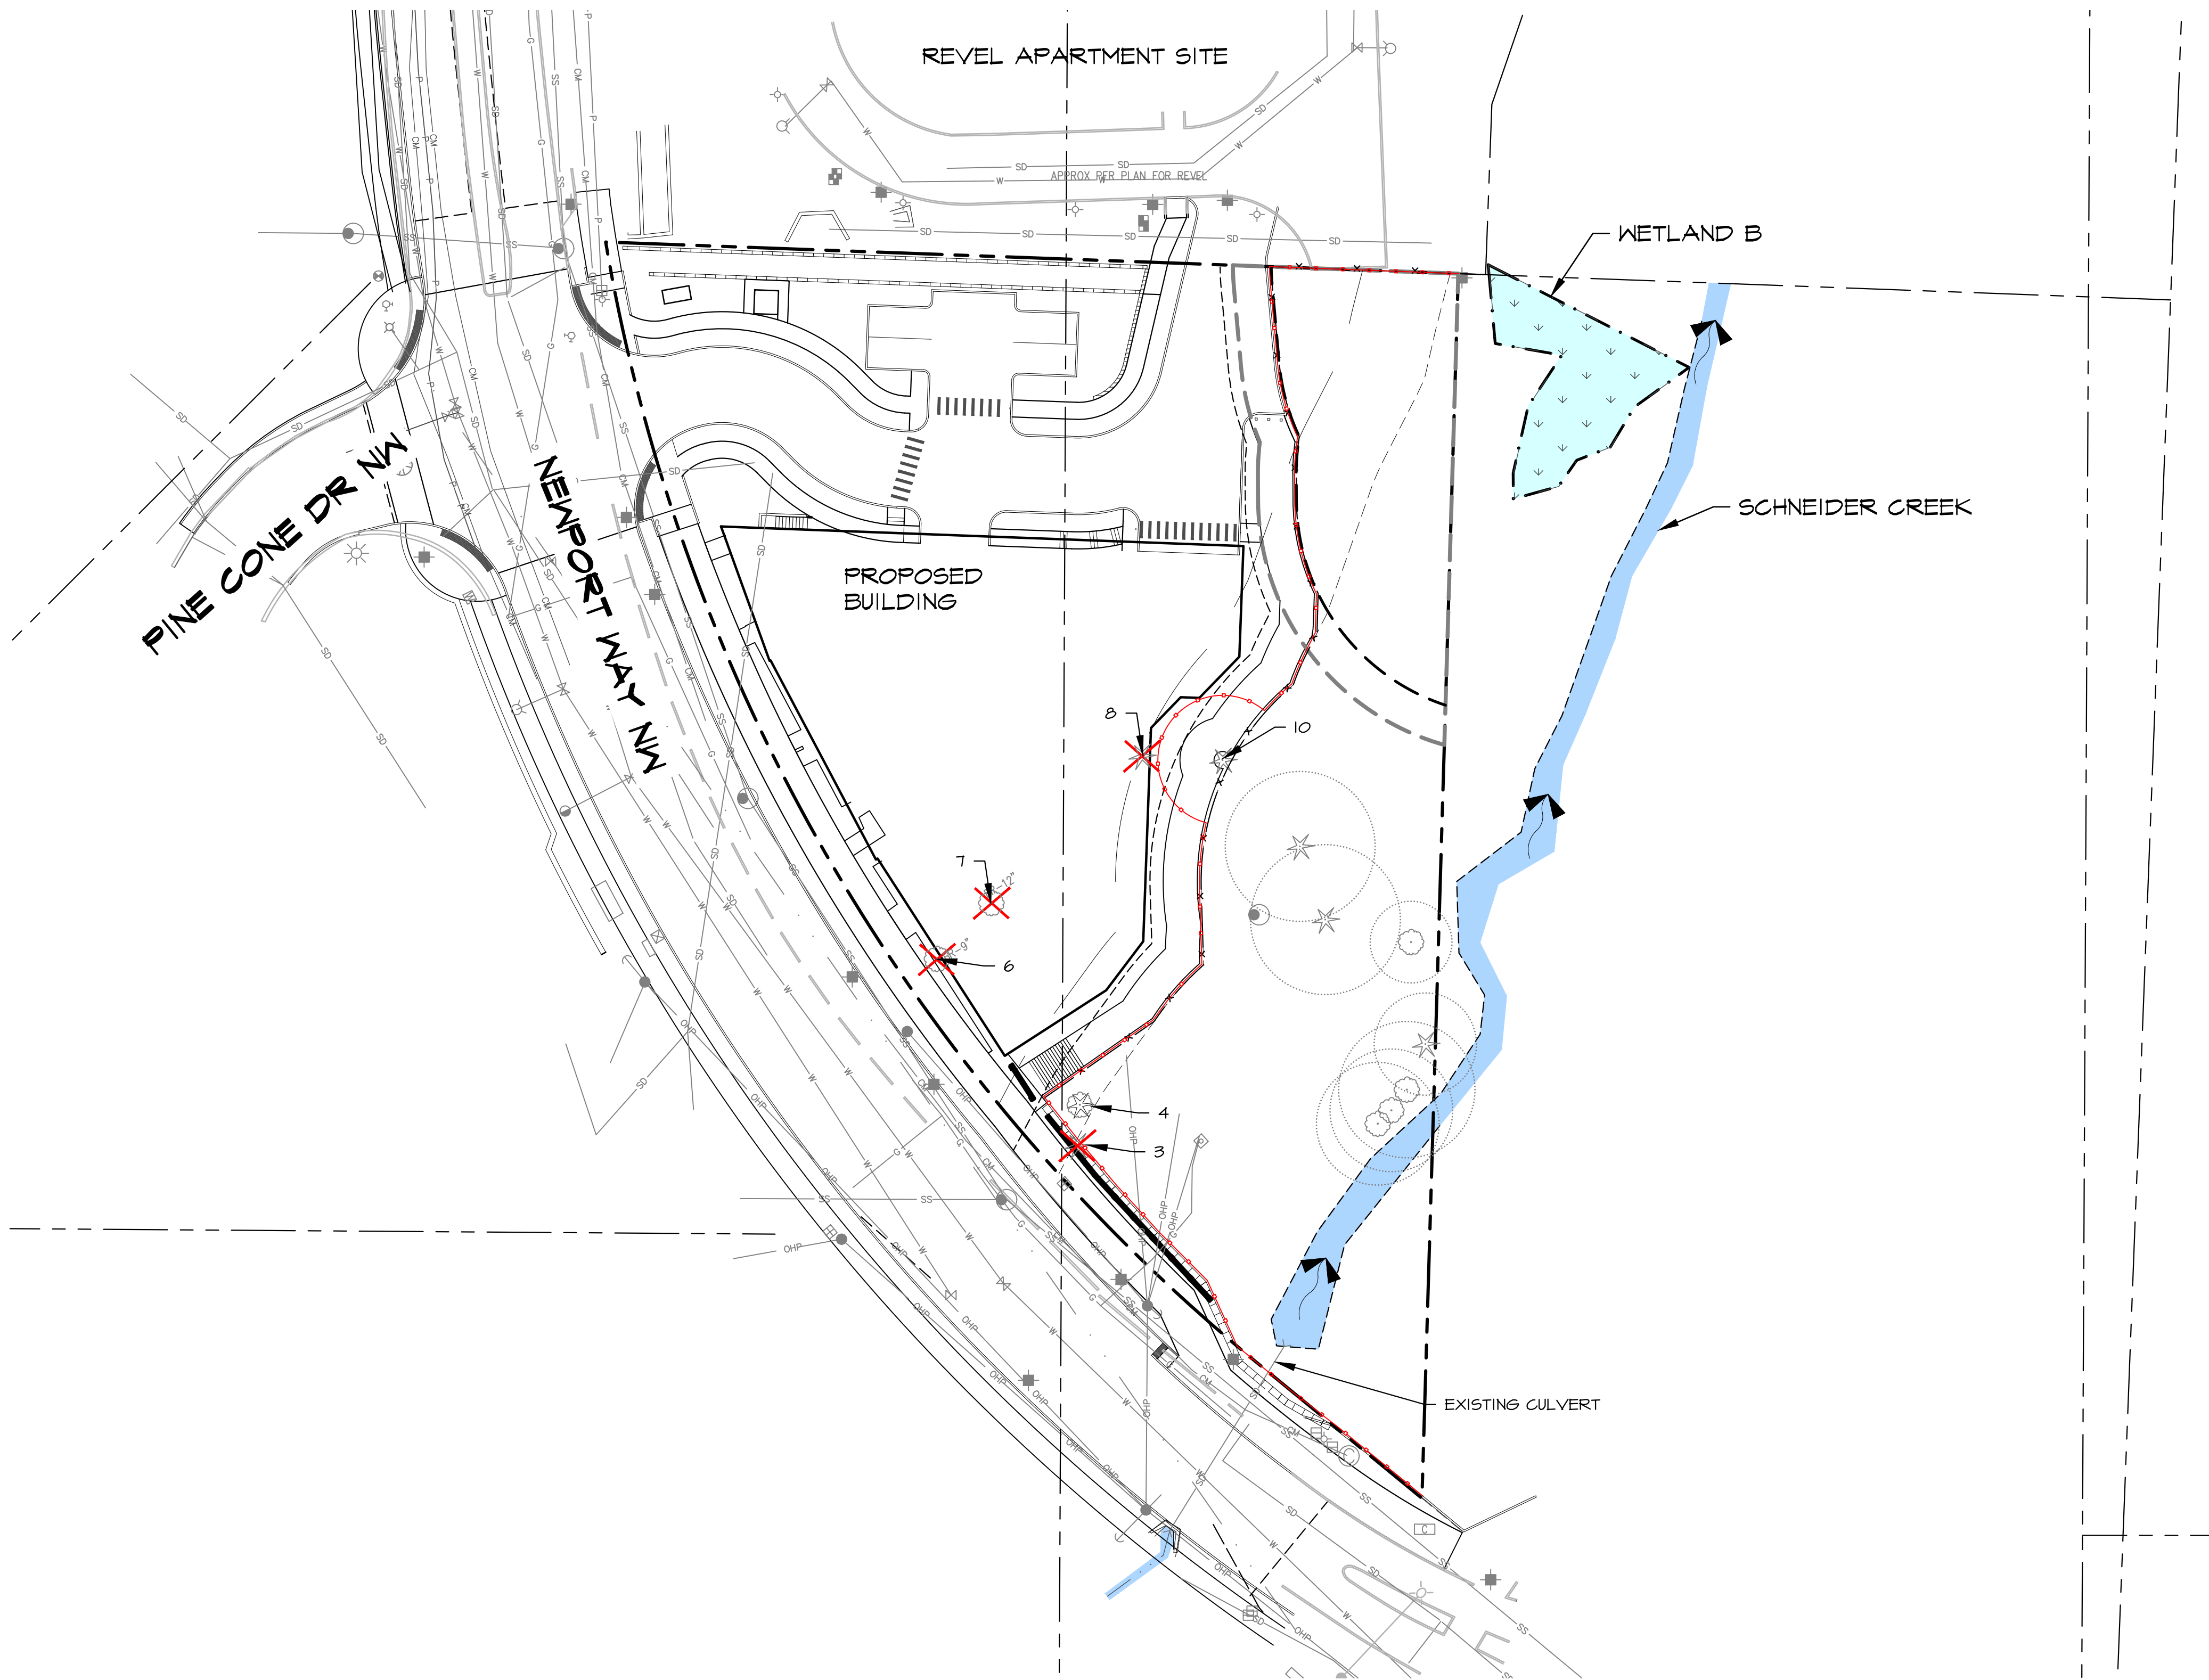
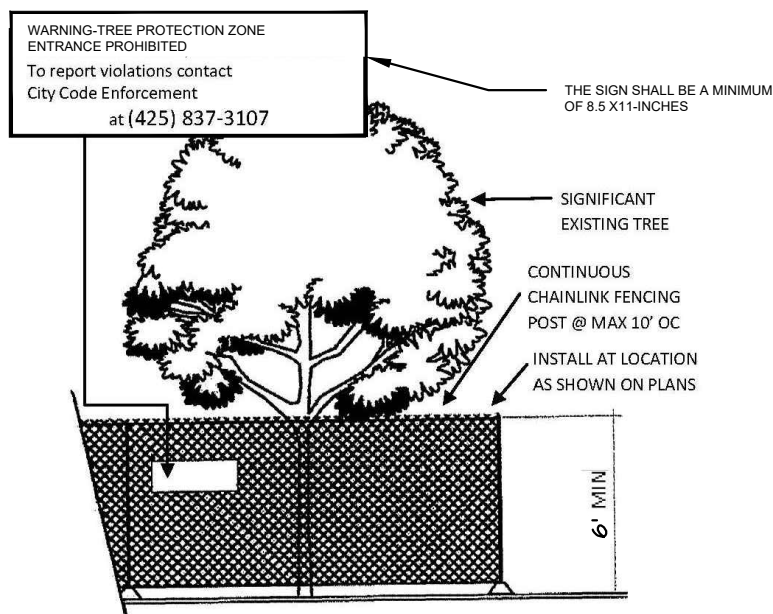
- WHERE PROPER SOIL EXCAVATION AND ROOT PRUNING TAKES PLACE, THE TREE PROTECTION ZONE (TPZ) FENCING MAY BE INSTALLED CLOSER TO THE TRUNK AND WILL NEED TO BE DETERMINED BY THE SITE ARBORIST AT THE TIME OF INSTALLATION.

- TREE PROTECTION FENCING WILL BE MODIFIED TO ALLOW FOR REASONABLE ENCROACHMENT INTO THE TPZ SO THAT SITE WORK CAN BE COMPLETED.
- TPZ SHALL BE A MINIMUM OF 6 FOOT HIGH CHAIN LINK FENCE AND MOUNTED ON TWO INCH DIAMETER METAL POSTS AT NO MORE THAN 10-FOOT SPACINGS. MOVABLE BARRIERS OF CHAIN LINK FENCING SECURED TO CEMENT BLOCKS MAY BE SUBSTITUTED FOR 'FIXED' FENCING IF THE PROJECT ARBORIST AGREES THAT THE FENCING WILL HAVE TO BE MOVED TO ACCOMMODATE CERTAIN PHASES OF CONSTRUCTION.

CRITICAL AREAS MITIGATION PLAN  
TREE RETENTION PLAN  
MILANO ISSAGUAH APARTMENTS PROJECT  
ISSAGUAH, WASHINGTON

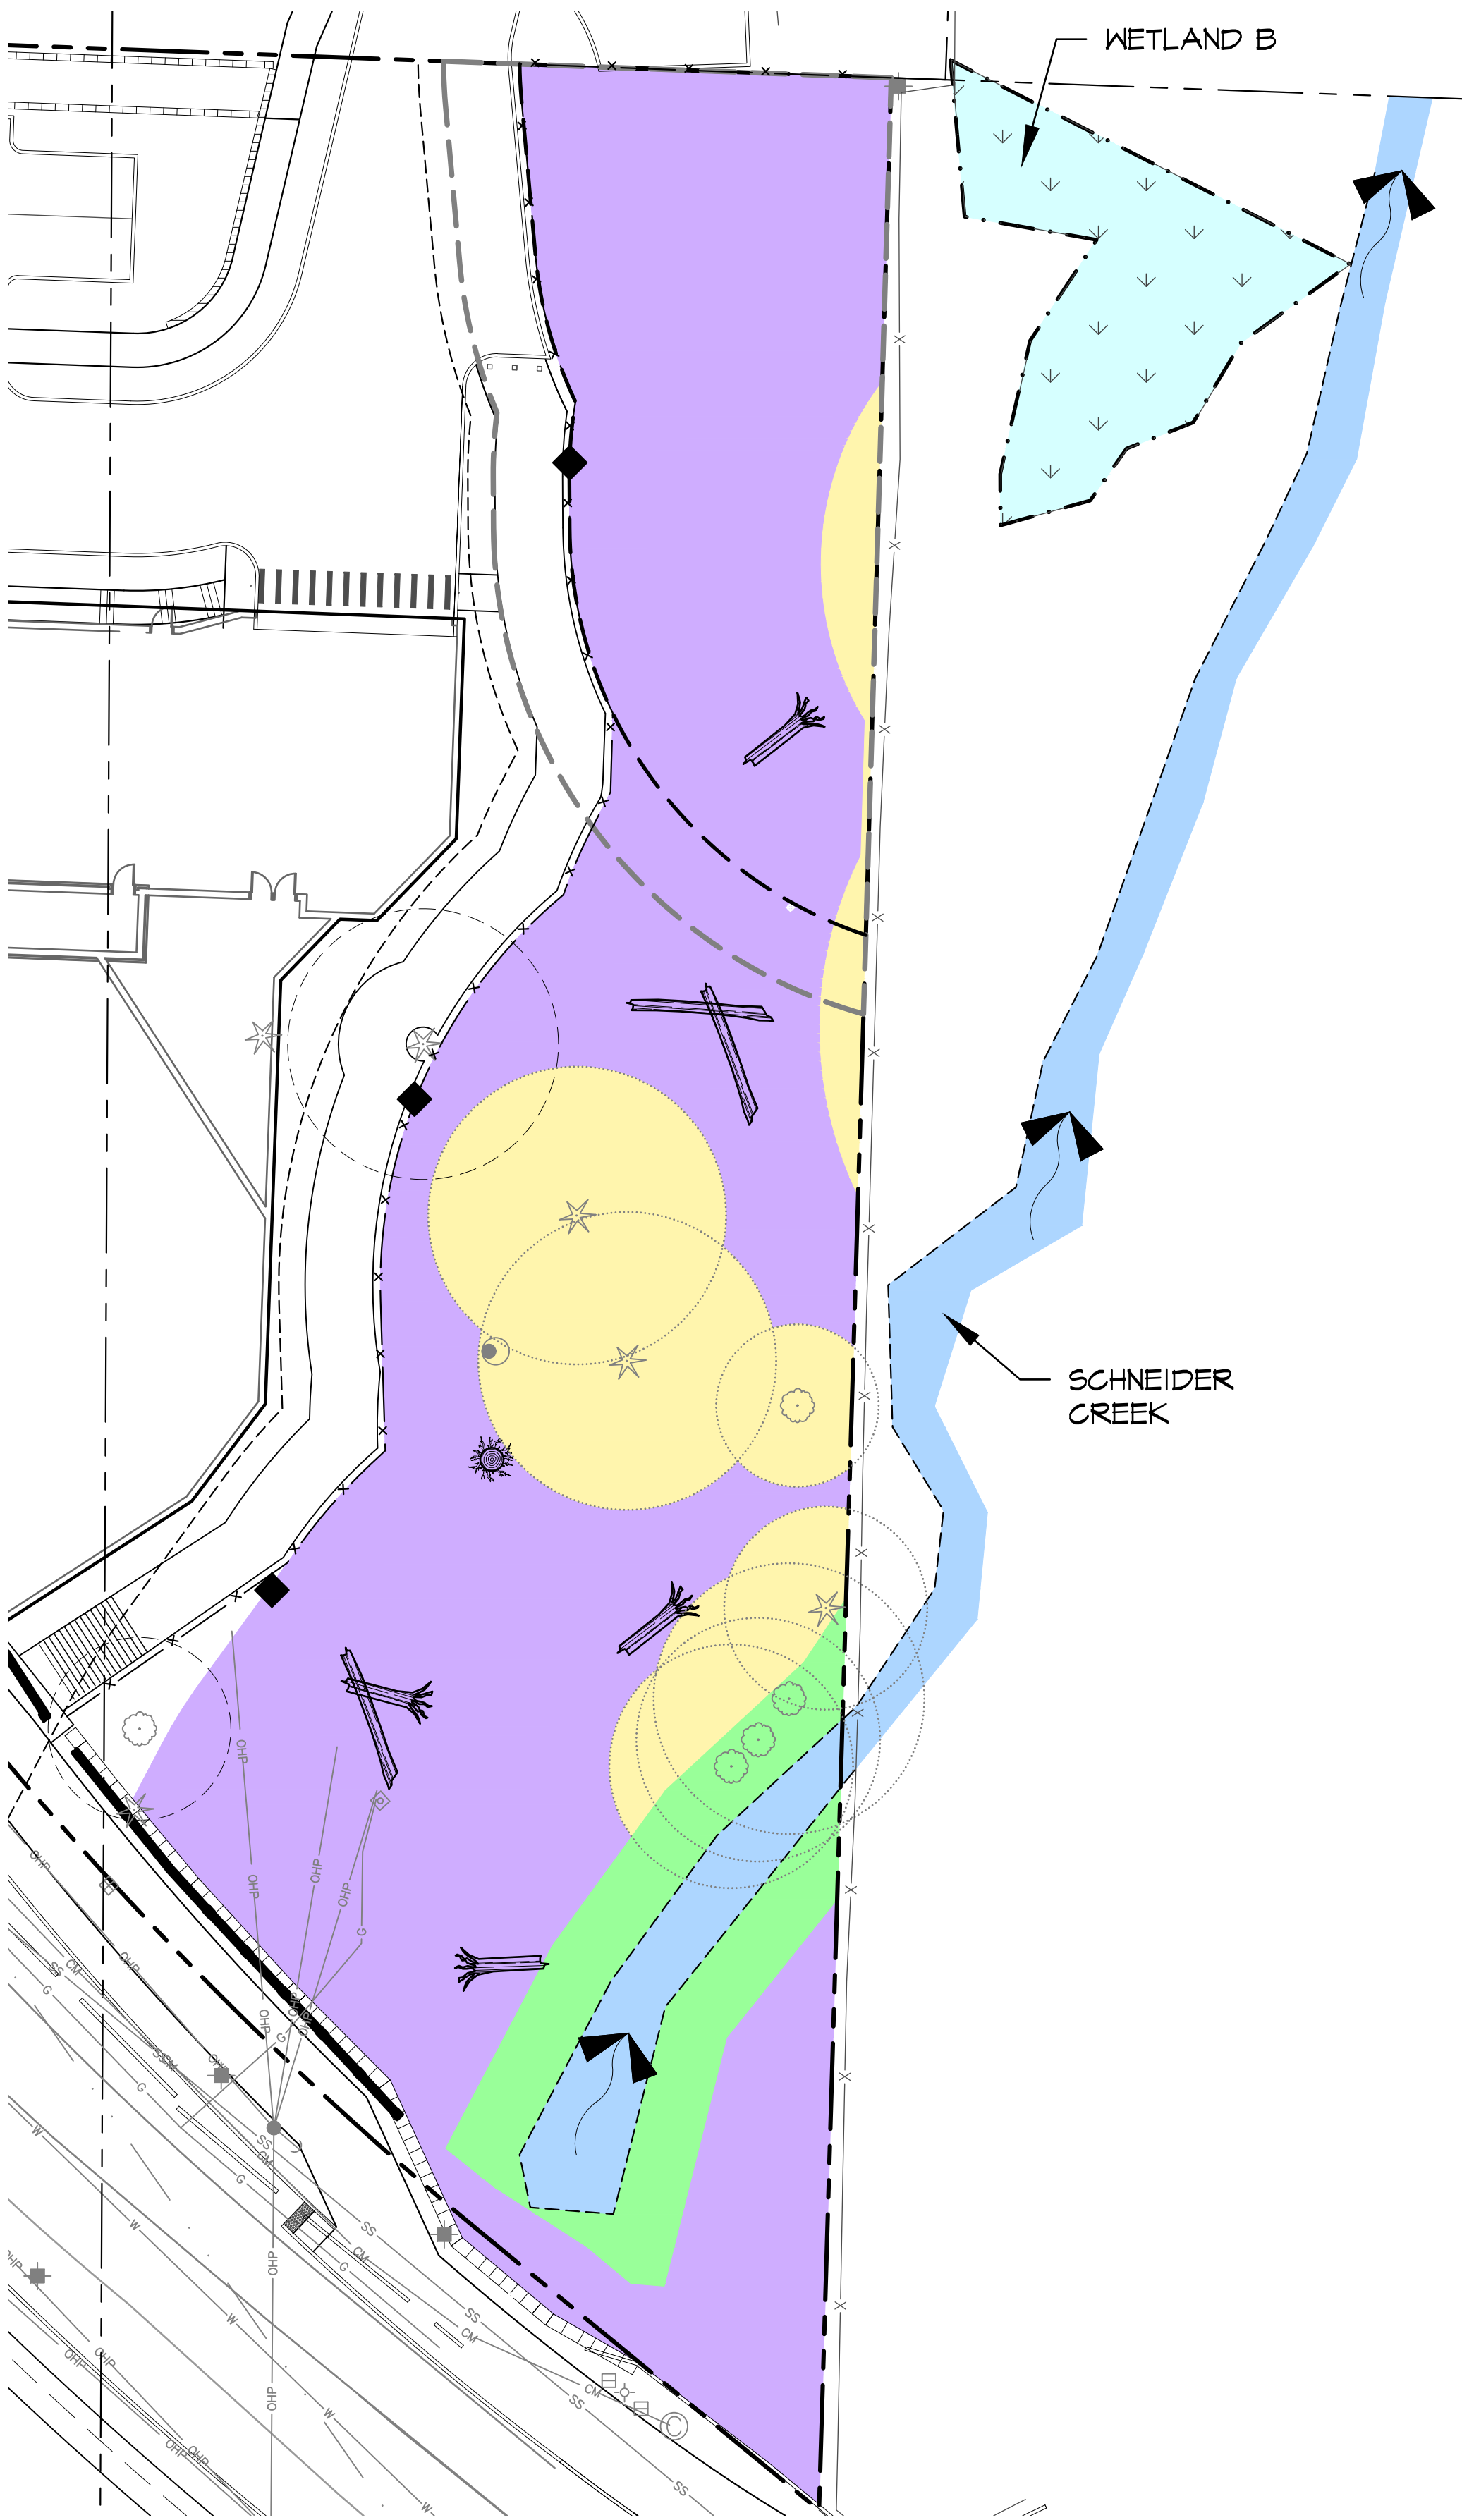
PLANTING PLAN

REQUIRED	PROPOSED
TREE PLANTING AREA	10,432 SF	
AREA WITHOUT TREES	1,726 SF	
TOTAL PLANTED AREA	20,658 SF	
TREES 9' O.C.	227	248
SHRUBS 6' O.C.	578	652
GROUND COVER 4' O.C.	5,164	5,164

Habitat features, including down logs and stumps will be imported and placed within these areas. These features provide shelter for small mammals and the slow decay of woody features contributes nutrients to the buffer area (**Sheet W5.0 of Appendix A**).

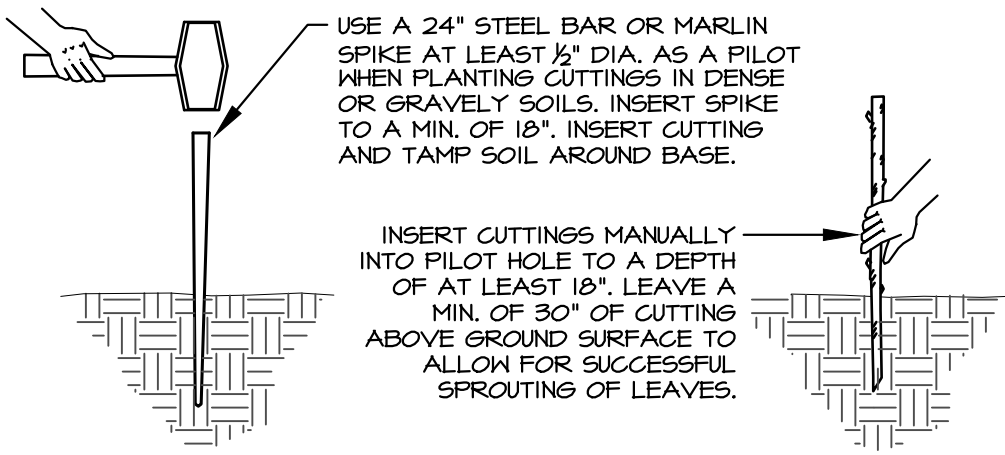
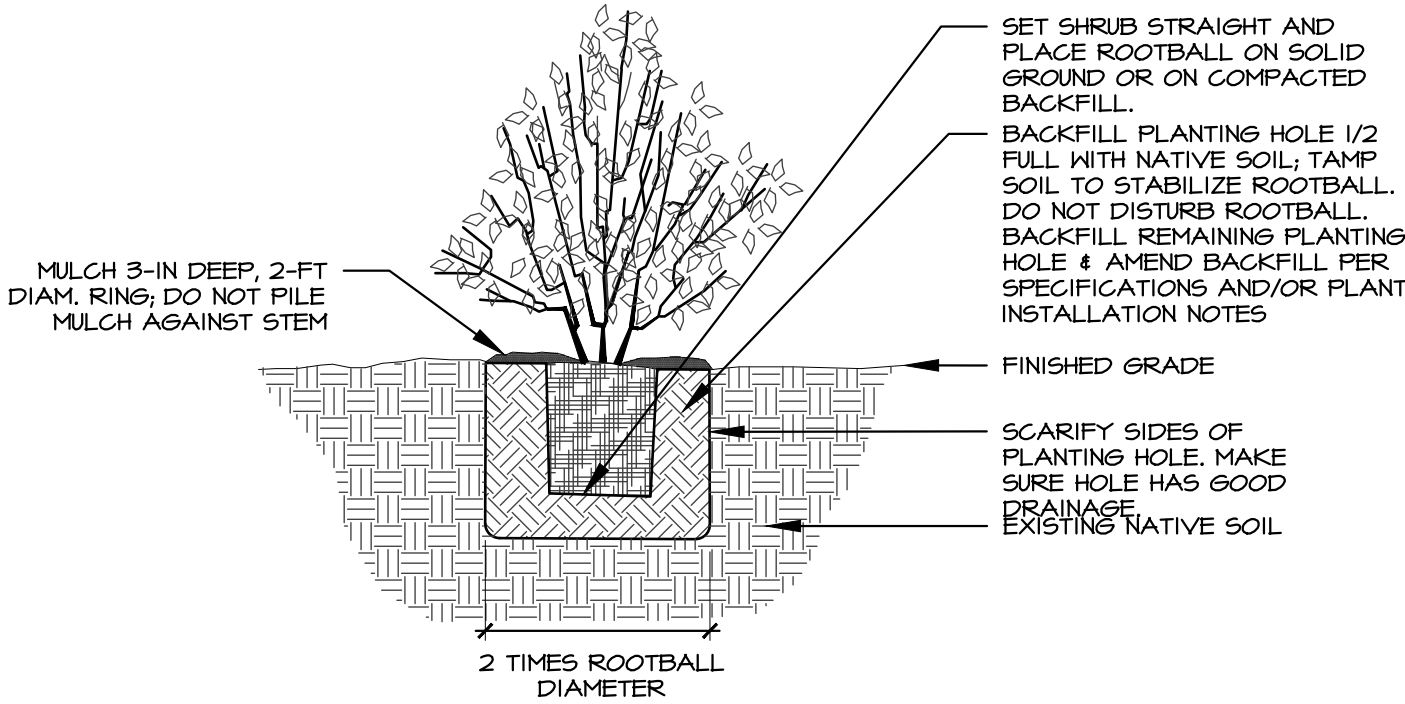
- NOTES:
- CUTTINGS SHALL BE SPECIES AS NOTED IN THE PLANT SCHEDULE.
  - CUTTINGS SHALL BE AT LEAST 1/2" IN DIA. AND 4' IN LENGTH.
  - CUTTINGS MUST BE MADE FROM LIVE AND VIGOROUS WOODY MATERIAL WITH SIDE BRANCHES REMOVED AND BARK INTACT.
  - THE BUTT ENDS SHALL BE CLEANLY CUT AT AN ANGLE FOR EASY INSERTION INTO THE SOIL.
  - THE TOP SHALL BE CUT SQUARE OR BLUNT.
  - CUTTINGS SHALL BE PLANTED WITHIN 24 HOURS OF CUTTING AND MUST BE KEPT MOIST AT ALL TIMES PRIOR TO PLANTING.
  - BOTTOM OF CUTTINGS SHALL BE TREATED WITH ROOTING HORMONE PRIOR TO PLANTING.

1 CUTTING INSTALLATION DETAIL  
N.T.S.

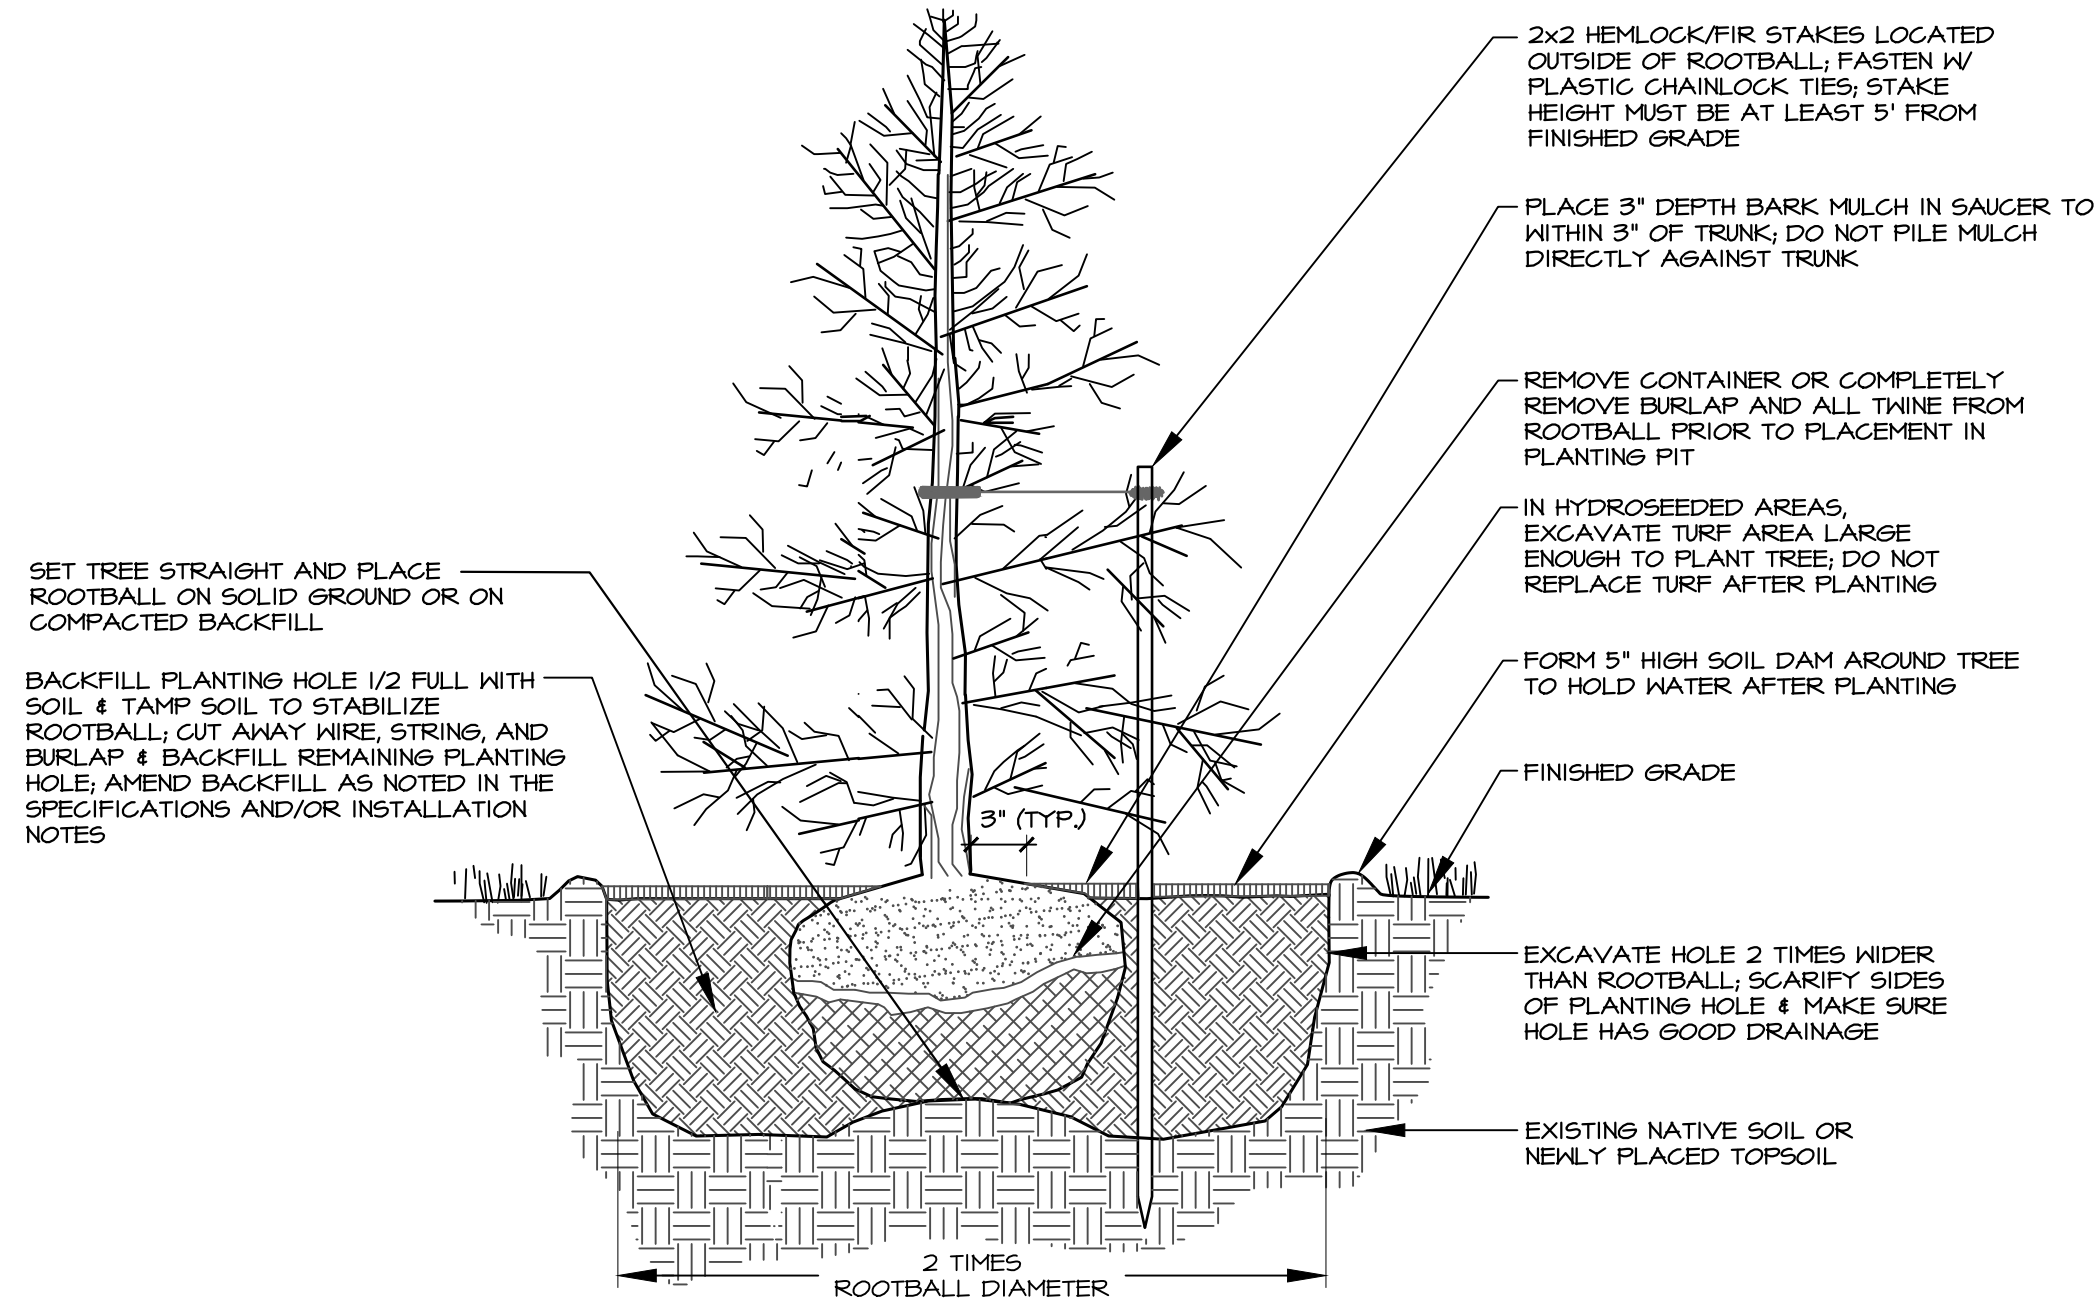
4 B&B CONIFER TREE PLANTING DETAIL  
N.T.S.

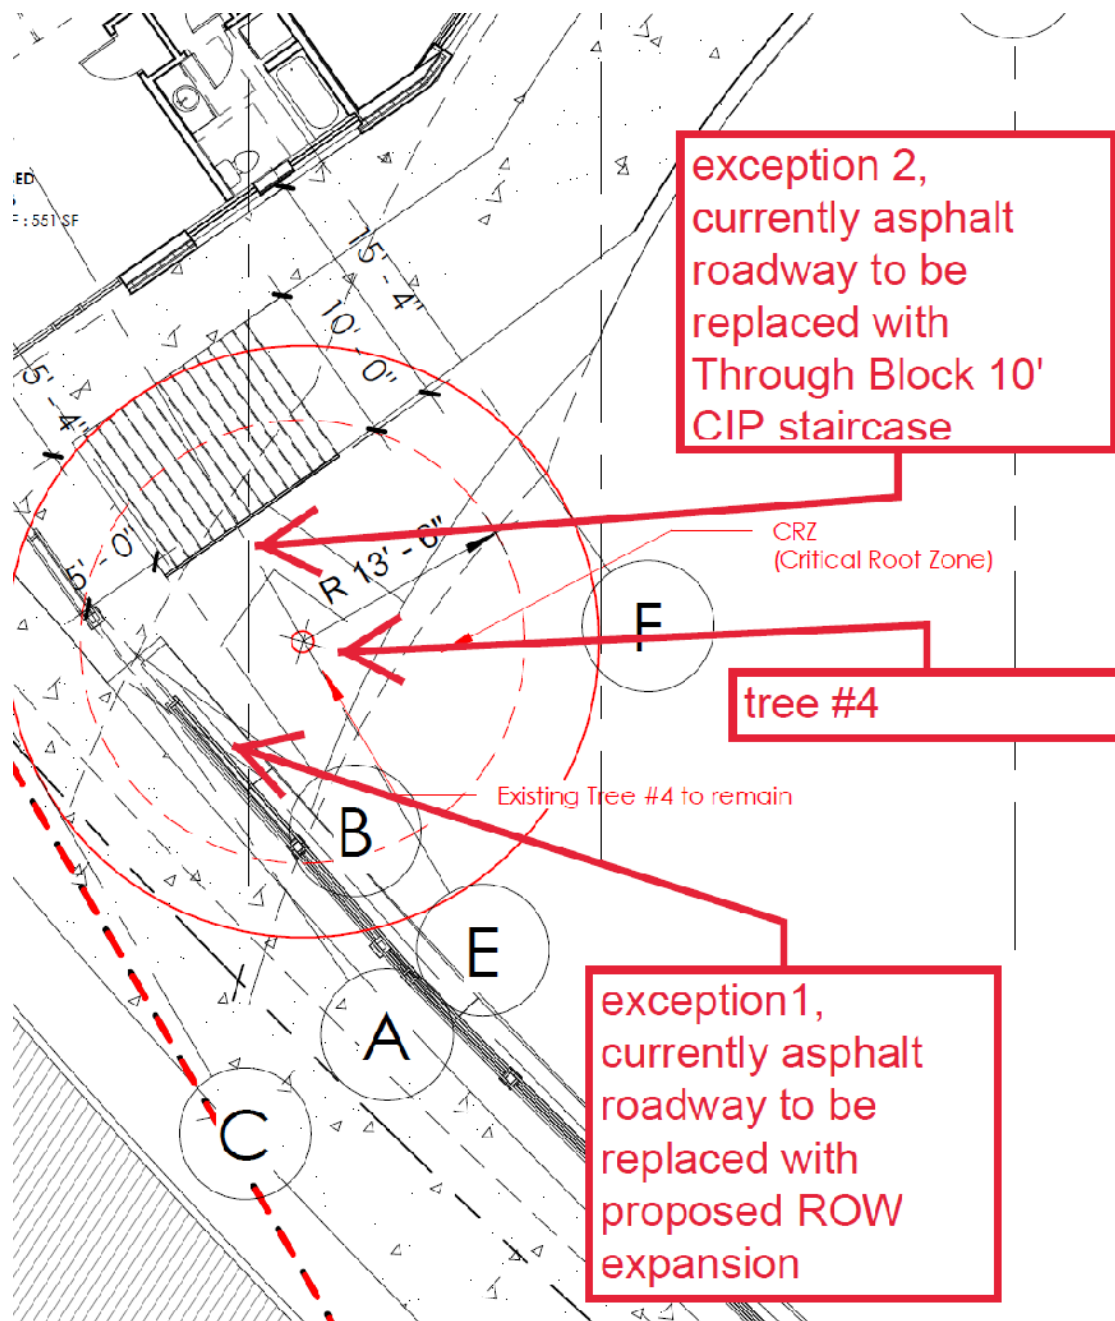
**Image 1. Site plan showing the LOD for development and the encroachment into the TPZ on the north and west edge of the TPZ fencing for Tree ID# 4. Encroachment for excavation is not likely to affect long-term health or viability of the tree as long as TPZ reduction and excavation follow the guidelines outlined in this memo.**
